**Project Name:** TEST JOB - WINCAN SURVEY  
**Project Description:** SITE DRAINAGE SURVEY  
**Project Number:** TEST JOB 001  
**Project Status:** Complete  
**Project Date:** 26/11/2021

The closed-circuit television survey was carried out for suspected issues causing repeated blockages.

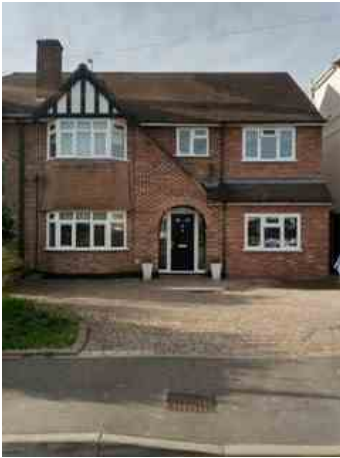
FRONT OF PROPERTY

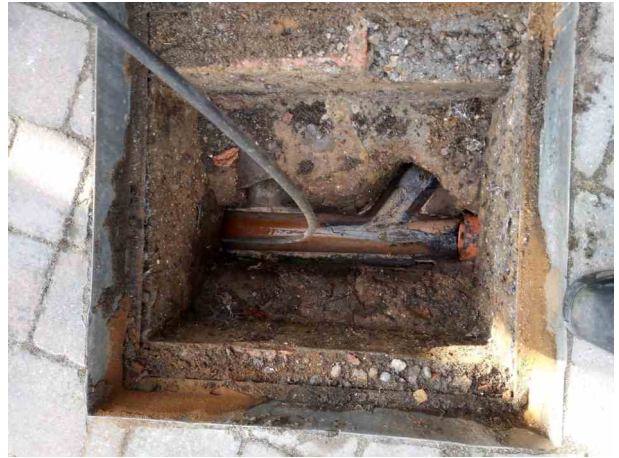
MANHOLE 2 OVERVIEW

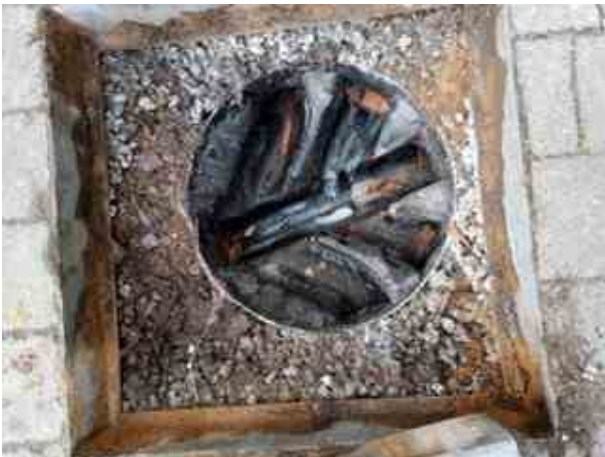
MANHOLE 1 OVERVIEW

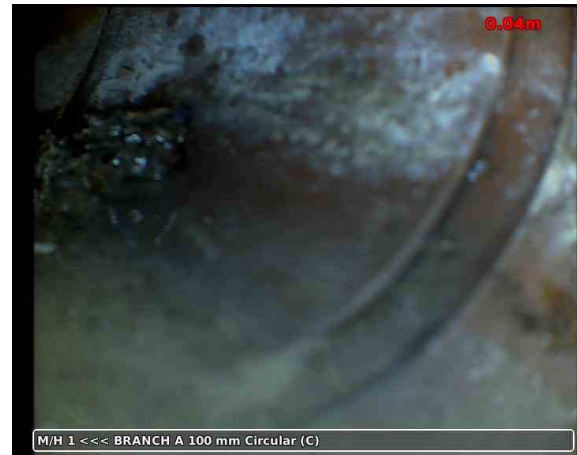
| Scale: | 1:50 | Position [m] | Code | Observation | MPEG | Photo | Grade |
|---|---|---|---|---|---|---|---|
| | | 0.04 | LL | Line deviates left | 00:00:14 | 20211118-111324-sn ap0001.jpg | |

20211118-111324-snap0001.jpg, 00:00:14, 0.04 m  
Line deviates left

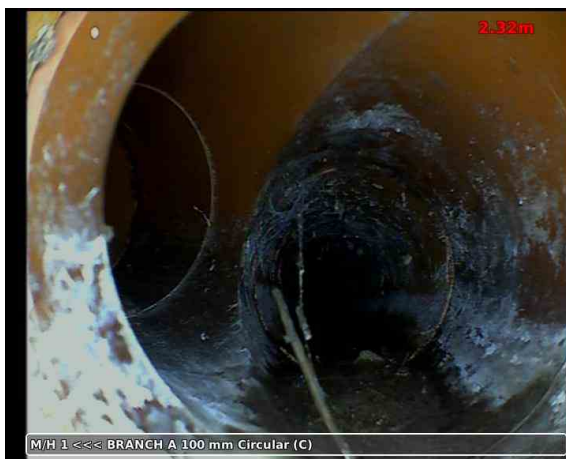
| Scale: | 1:50 | Position [m] | Code | Observation | MPEG | Photo | Grade |
|---|---|---|---|---|---|---|---|
| | | 2.32 | JN | Junction at 9 o'clock, 100mm dia | 00:00:31 | 20211118-111324-sn ap0002.jpg | |

20211118-111324-snap0002.jpg, 00:00:31, 2.32 m  
Junction at 9 o'clock, 100mm dia

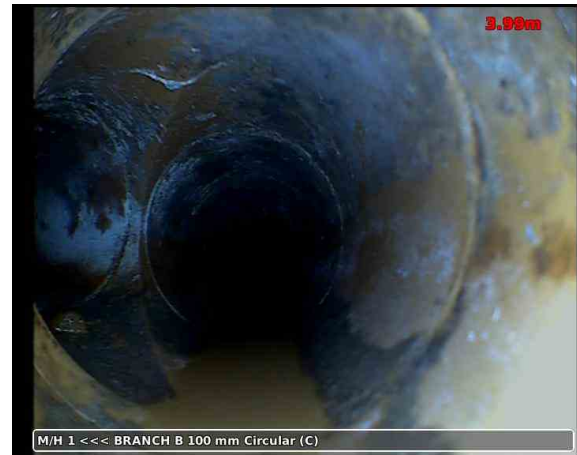
| Scale: | 1:50 | Position [m] | Code | Observation | MPEG | Photo | Grade |
|---|---|---|---|---|---|---|---|
| | 3.99 | JN | | Junction at 9 o'clock, 100mm dia | 00:00:30 | 20211118-111716-sn ap0001.jpg | |

20211118-111716-snap0001.jpg, 00:00:30, 3.99 m  
Junction at 9 o'clock, 100mm dia

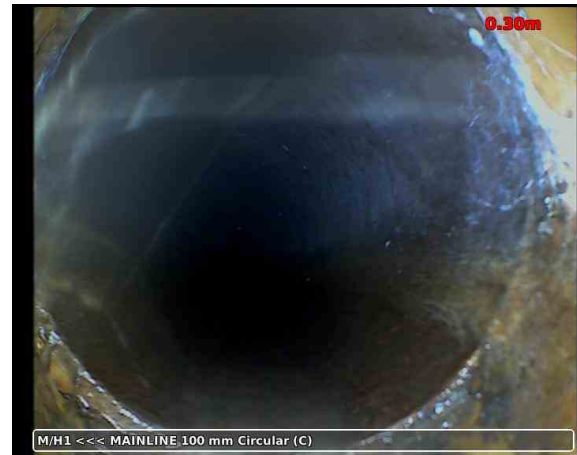
| Scale: | 1:50 | Position [m] | Code | Observation | MPEG | Photo | Grade |
|---|---|---|---|---|---|---|---|
| | | 0.30 | MCVC | Pipe material changes to vitrified clay at this point | 00:00:27 | 20211118-121526-sn ap0001.jpg | |

20211118-121526-snap0001.jpg, 00:00:27, 0.30 m  
Pipe material changes to vitrified clay at this point

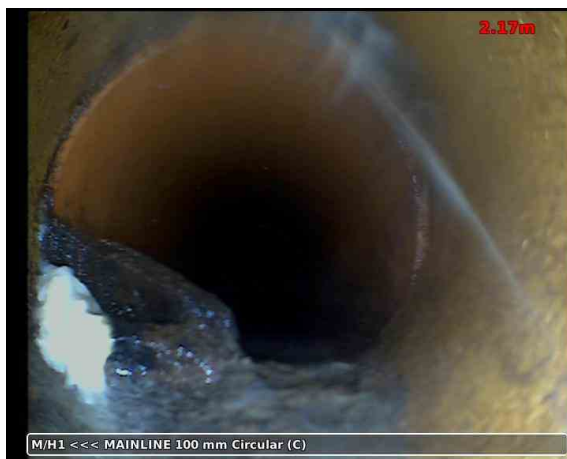
| Scale: | 1:50 | Position [m] | Code | Observation | MPEG | Photo | Grade |
|---|---|---|---|---|---|---|---|
| | | 2.17 | DECJ | Settled deposits, hard or compacted at joint, 35% cross-sectional area loss | 00:00:49 | 20211118-121526-sn ap0002.jpg | 4 |
| | | 2.39 | SA | Survey abandoned: UNABLE TO PASS BUILD UP | 00:01:09 | | |

20211118-121526-snap0002.jpg, 00:00:49, 2.17 m  
Settled deposits, hard or compacted at joint, 35% cross-sectional area loss

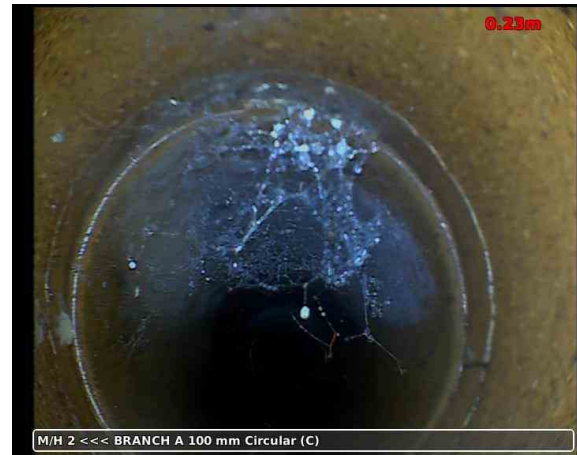
The survey has revealed some structural defects to the drainage system such as circumferential cracks on branch a - M/H 2, we did note that the system is linked with the neighbouring property, they had a interceptor drain on the front drive that was blocked. The blockage was cleared, and flow was restored to the drainage system.

| Scale: | 1:50 | Position [m] | Code | Observation | MPEG | Photo | Grade |
|---|---|---|---|---|---|---|---|
| | 0.19 | CC | | Crack, circumferential from 12 o'clock to 12 o'clock | 00:00:12 | 20211118-122214-sn ap0001.jpg | 2 / 2 |

20211118-122214-snap0001.jpg, 00:00:12, 0.19 m  
Crack, circumferential from 12 o'clock to 12 o'clock

We have submitted an on-site agreement with all remedial works should you have any queries please do not hesitate to contact us.

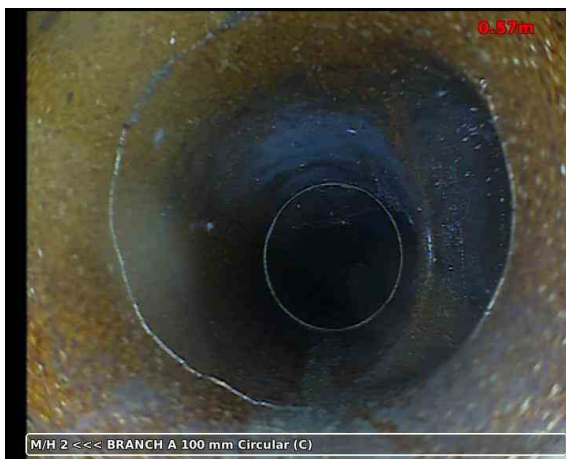
| Scale: | 1:50 | Position [m] | Code | Observation | MPEG | Photo | Grade |
|---|---|---|---|---|---|---|---|
| | 0.57 | CCJ | | Crack, circumferential at joint from 12 o'clock to 12 o'clock | 00:00:24 | 20211118-122214-sn ap0002.jpg | 2 / 2 |

20211118-122214-snap0002.jpg, 00:00:24, 0.57 m  
Crack, circumferential at joint from 12 o'clock to 12 o'clock

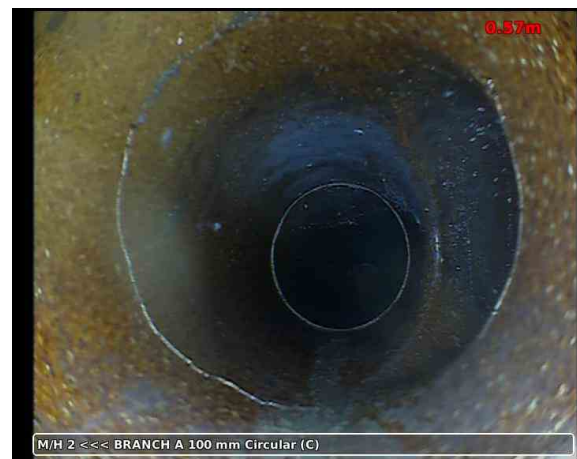
| Scale: | 1:50 | Position [m] | Code | Observation | MPEG | Photo | Grade |
|---|---|---|---|---|---|---|---|
| | 0.57 | JN | | Junction at 3 o'clock, 100mm dia | 00:00:34 | 20211118-122214-sn ap0003.jpg | |

20211118-122214-snap0003.jpg, 00:00:34, 0.57 m  
Junction at 3 o'clock, 100mm dia

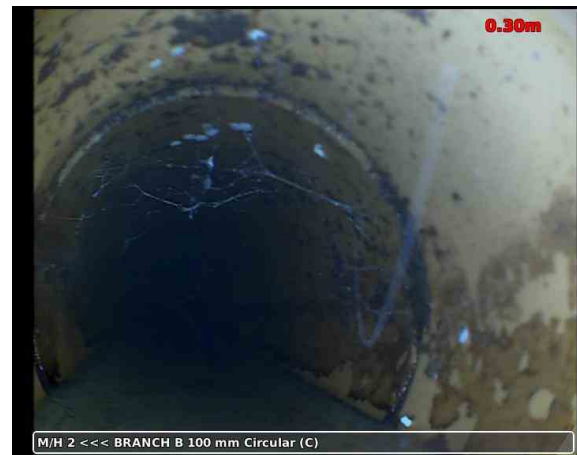
| Scale: | 1:59 | Position [m] | Code | Observation | MPEG | Photo | Grade |
|---|---|---|---|---|---|---|---|
| | 0.30 | LL | | Line deviates left | 00:00:12 | 20211118-122550-sn ap0001.jpg | |

20211118-122550-snap0001.jpg, 00:00:12, 0.30 m  
Line deviates left

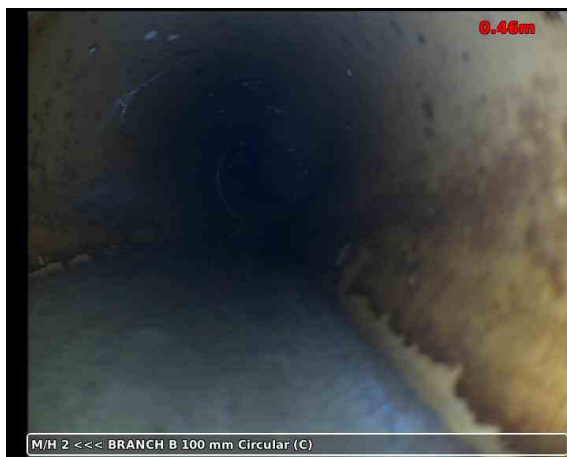
| Scale: | 1:59 | Position [m] | Code | Observation | MPEG | Photo | Grade |
|---|---|---|---|---|---|---|---|
| | 0.46 | S01 | CUW | Loss of vision, camera under water, start | 00:00:18 | 20211118-122550-sn ap0002.jpg | |

20211118-122550-snap0002.jpg, 00:00:18, 0.46 m  
Loss of vision, camera under water, start

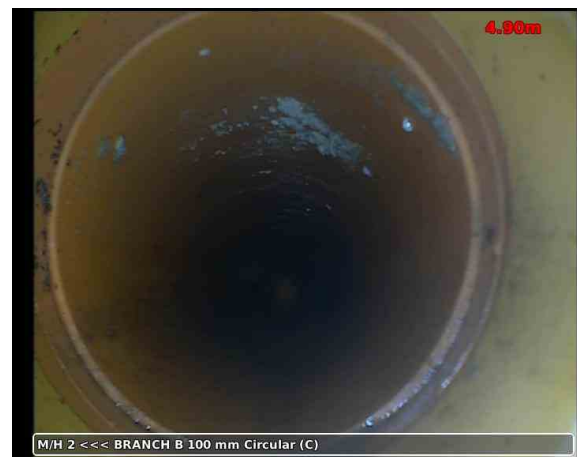
| Scale: | 1:59 | Position [m] | Code | Observation | MPEG | Photo | Grade |
|---|---|---|---|---|---|---|---|
| | 4.90 | MCPVC | | Pipe material changes to polyvinyl chloride at this point | 00:01:00 | 20211118-122550-sn ap0003.jpg | |

20211118-122550-snap0003.jpg, 00:01:00, 4.90 m  
Pipe material changes to polyvinyl chloride at this point

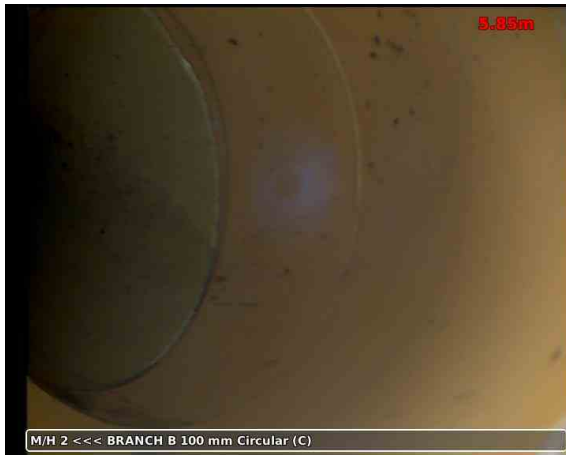
| Scale: | 1:59 | Position [m] | Code | Observation | MPEG | Photo | Grade |
|---|---|---|---|---|---|---|---|
| | 5.85 | LL | | Line deviates left | 00:01:09 | 20211118-122550-sn ap0004.jpg | |

20211118-122550-snap0004.jpg, 00:01:09, 5.85 m  
Line deviates left

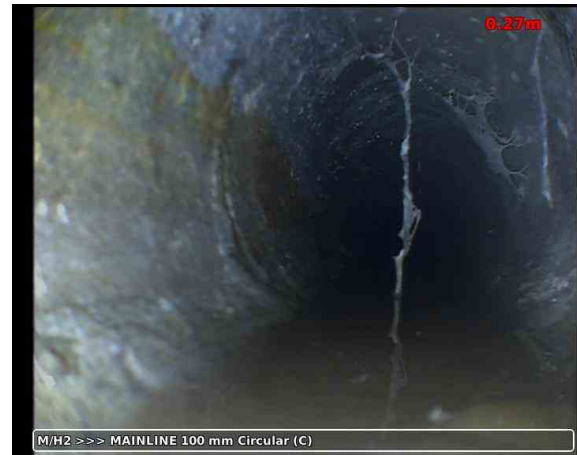
20211118-122831-snap0001.jpg, 00:00:12, 0.27 m  
Loss of vision, camera under water, start

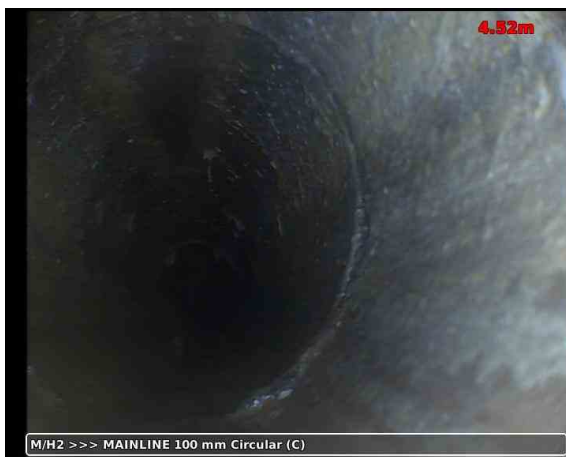
20211118-122831-snap0002.jpg, 00:00:41, 4.48 m  
General remark, CLEARED I/C IN NUMBER 18
